The Exshaw Quarry on Grotto Mountain, near Canmore, Alberta and possible rock-slide hazard in the area

Historical background, tour notes, discussion and recommendations

24 February 2017

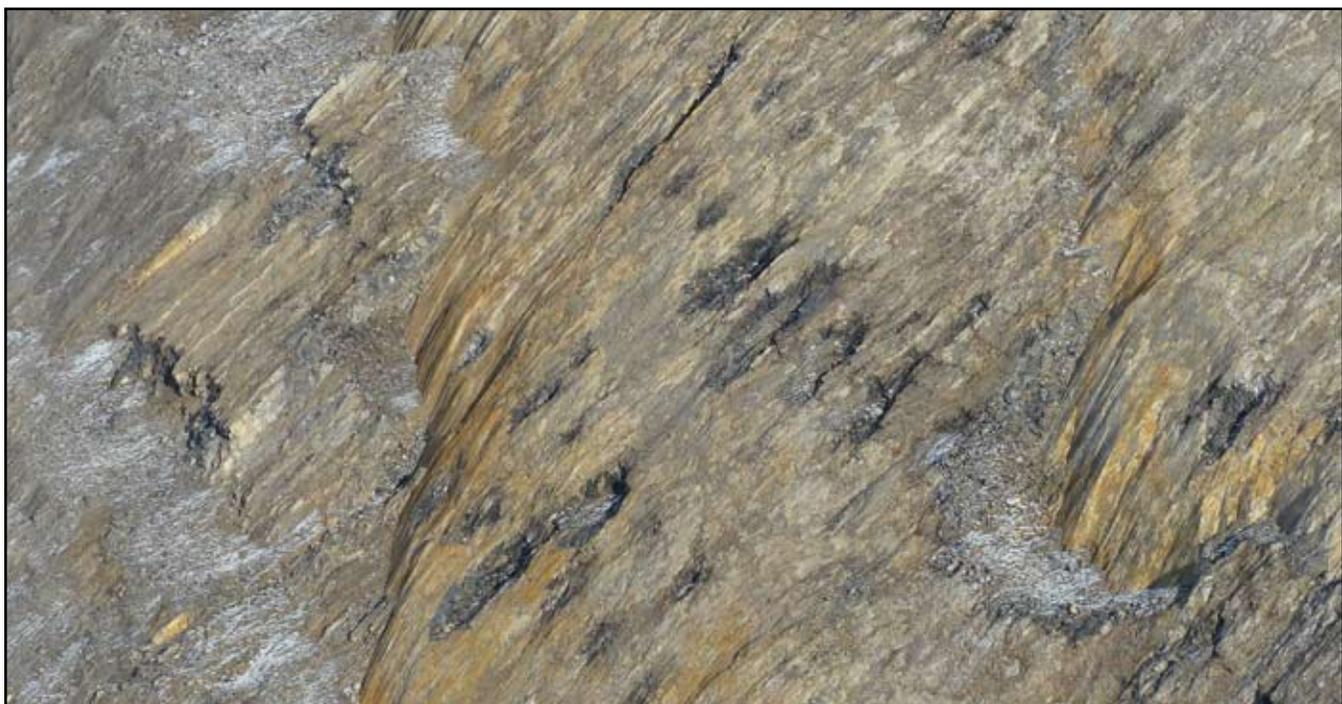
Figure 5, closer view of the footwall, showing the faulted surface. Pits in the wall are from blasting.

The footwall of the entire quarry seemed to me to be a fault surface, smoothed and striated by rock movement. (See Figure 5.) Lee Nichols confirmed this impression. I asked Grant Robinson whether the presence of the fault aids quarrying, because the rock might break away from the footwall rather easily along the fault surface. Grant stated that this was true.
